3284 Banbury Lane Bridge, Rothersthorpe

Banbury Lane Bridge is a 6.75m single span masonry structure carrying the C86 Banbury Lane between Rothersthorpe and Hunsbury Meadows.

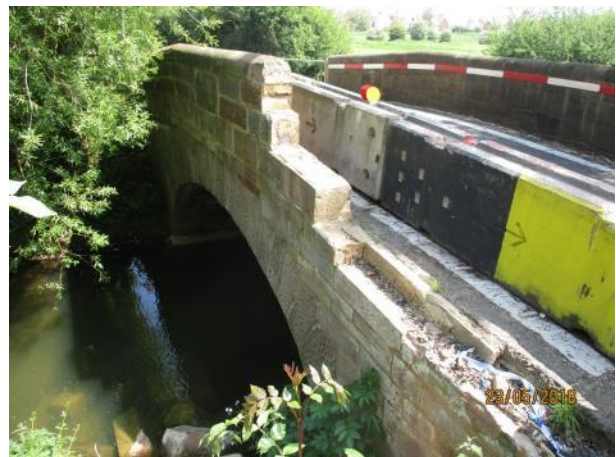
On the 1st December 2017 the bridge was struck by an errant vehicle causing significant damage to the north parapet. The structure has sustained significant damage and loss of stonework as a result of the impact.

- Retrieval of stonework from the watercourse and adjacent embankment.
- Repair/replacement of the damaged stonework section on the north parapet.
